Stability Evaluation of Dam Surrounding Rock Mass and Environmentally-friendly Measures

ダム周辺岩体の安定度評価と環境に優しい対策

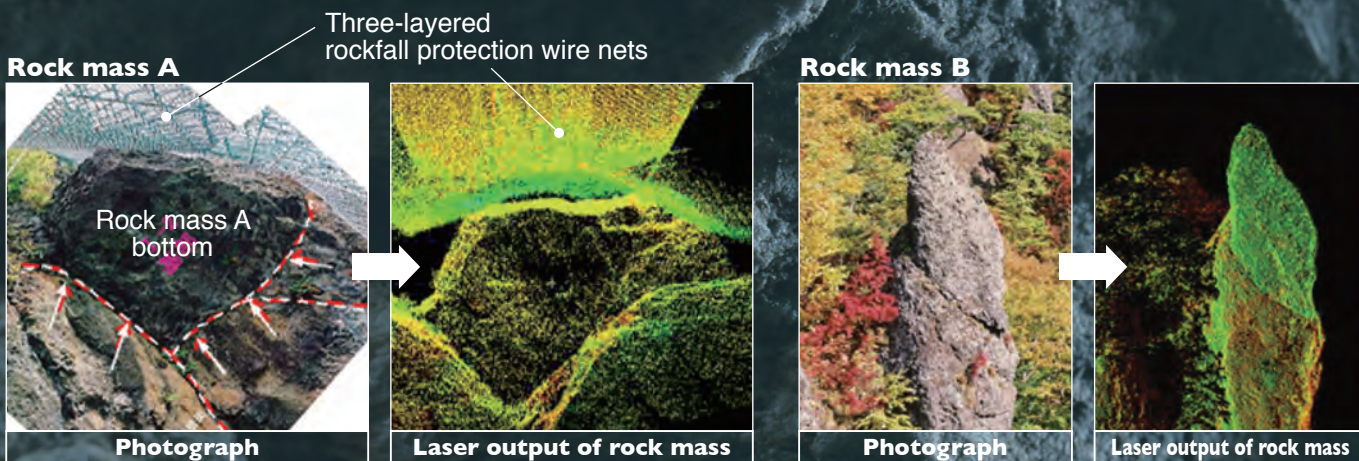
This technique is a system that conducts laser ranging at a close distance and multiple points. With this method, it is possible to make high-speed, high-precision 3D measurements. In particular, using high-density irradiation, the shape of the rock mass covered by the rock net could also be ascertained by permeating the net.

本技術は近距離かつ多点でレーザー測距を行うシステムであり、3次元での高速、高精度の計測が可能です。特に高密度のレーザー照射により、ロックネットに覆われた岩体もネットを透過して形状や大きさを把握できます。

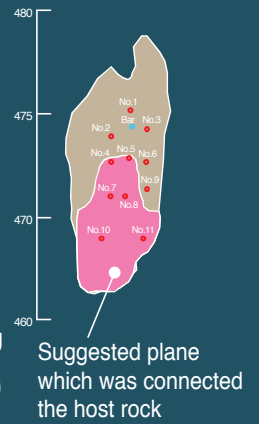
Situation of impacting the rock surface with a hammer(for trigger)

This technique is one form of non-destructive probing, and is a probing system that uses the basic principle of the impact elastic wave method. Although the same shockwaves as the conventional impact elastic wave method are used, it is possible to estimate the locations of cracks in the rear surface of the rock mass more clearly by measuring the propagation time and setting the P wave speed, focusing mainly on high-frequency reflected waves in the rock mass.

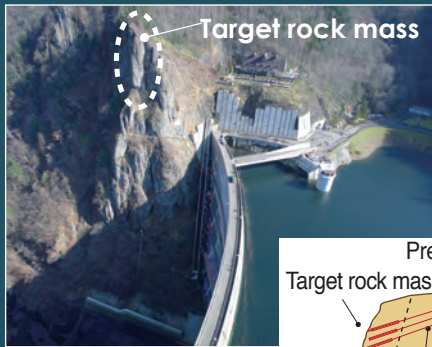
A special feature of this engineering method is that anchor components are not exposed to the rock face, as a shaft is created in the rear bedrock, and a pressure plate is installed inside the shaft. Since the rock mass surface is not altered, the natural appearance is preserved with no differences to its original state. This construction work on a single rock mass is the first to take place in Japan.

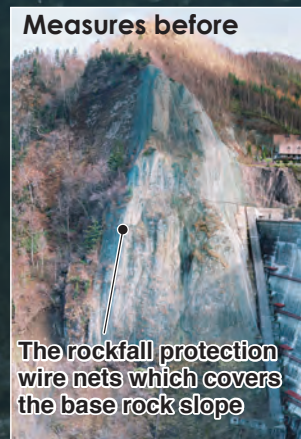
The rockfall protection wire nets which covers the base rock slope

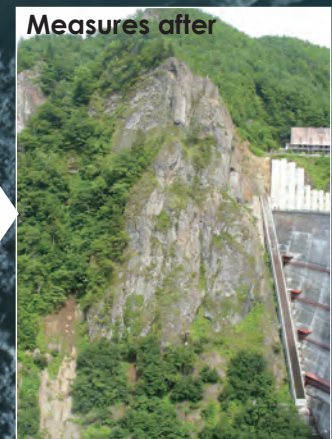
The rock net that had been covering the rock slope was removed, and the attractively rough surface of the rock was restored to its original condition.

岩盤斜面を覆っていたロックネットは撤去され、元来の美しく荒々しい岩肌が復元されました。
